## SUPPLEMENT

# RCA Victor Radiola R-11 Service Notes

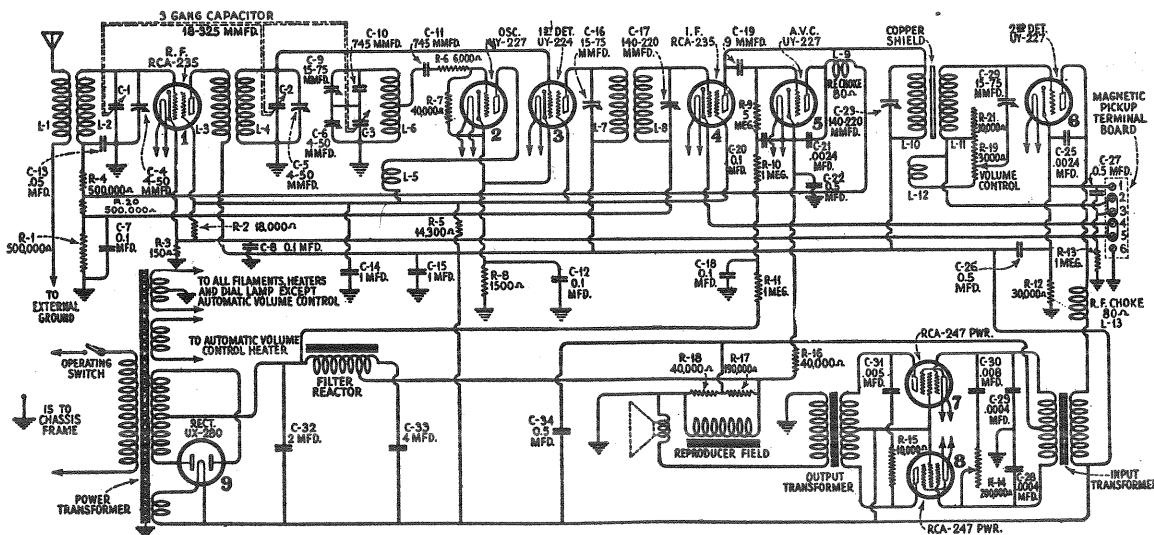
Late production of the RCA Victor Radiola R-11 has a slight change in the wiring, two changes in capacitor values and the addition of a 0.5 megohm resistor (R-20). Capacitor C-7 has been changed from 0.5 mfd. to 0.1 mfd. and C-13 from 0.1 mfd. to 0.05 mfd. Resistor R-20 has been added.

Figure 1—Revised Schematic diagram of late production R-11

The replacement parts listed and supplied are entirely interchangeable with either the old or new models. In the case of the older models, however, the additional black lead supplied in the new capacitor pack should be joined to the old black ground lead. All other capacitor leads are exactly the same and are soldered to the same points.

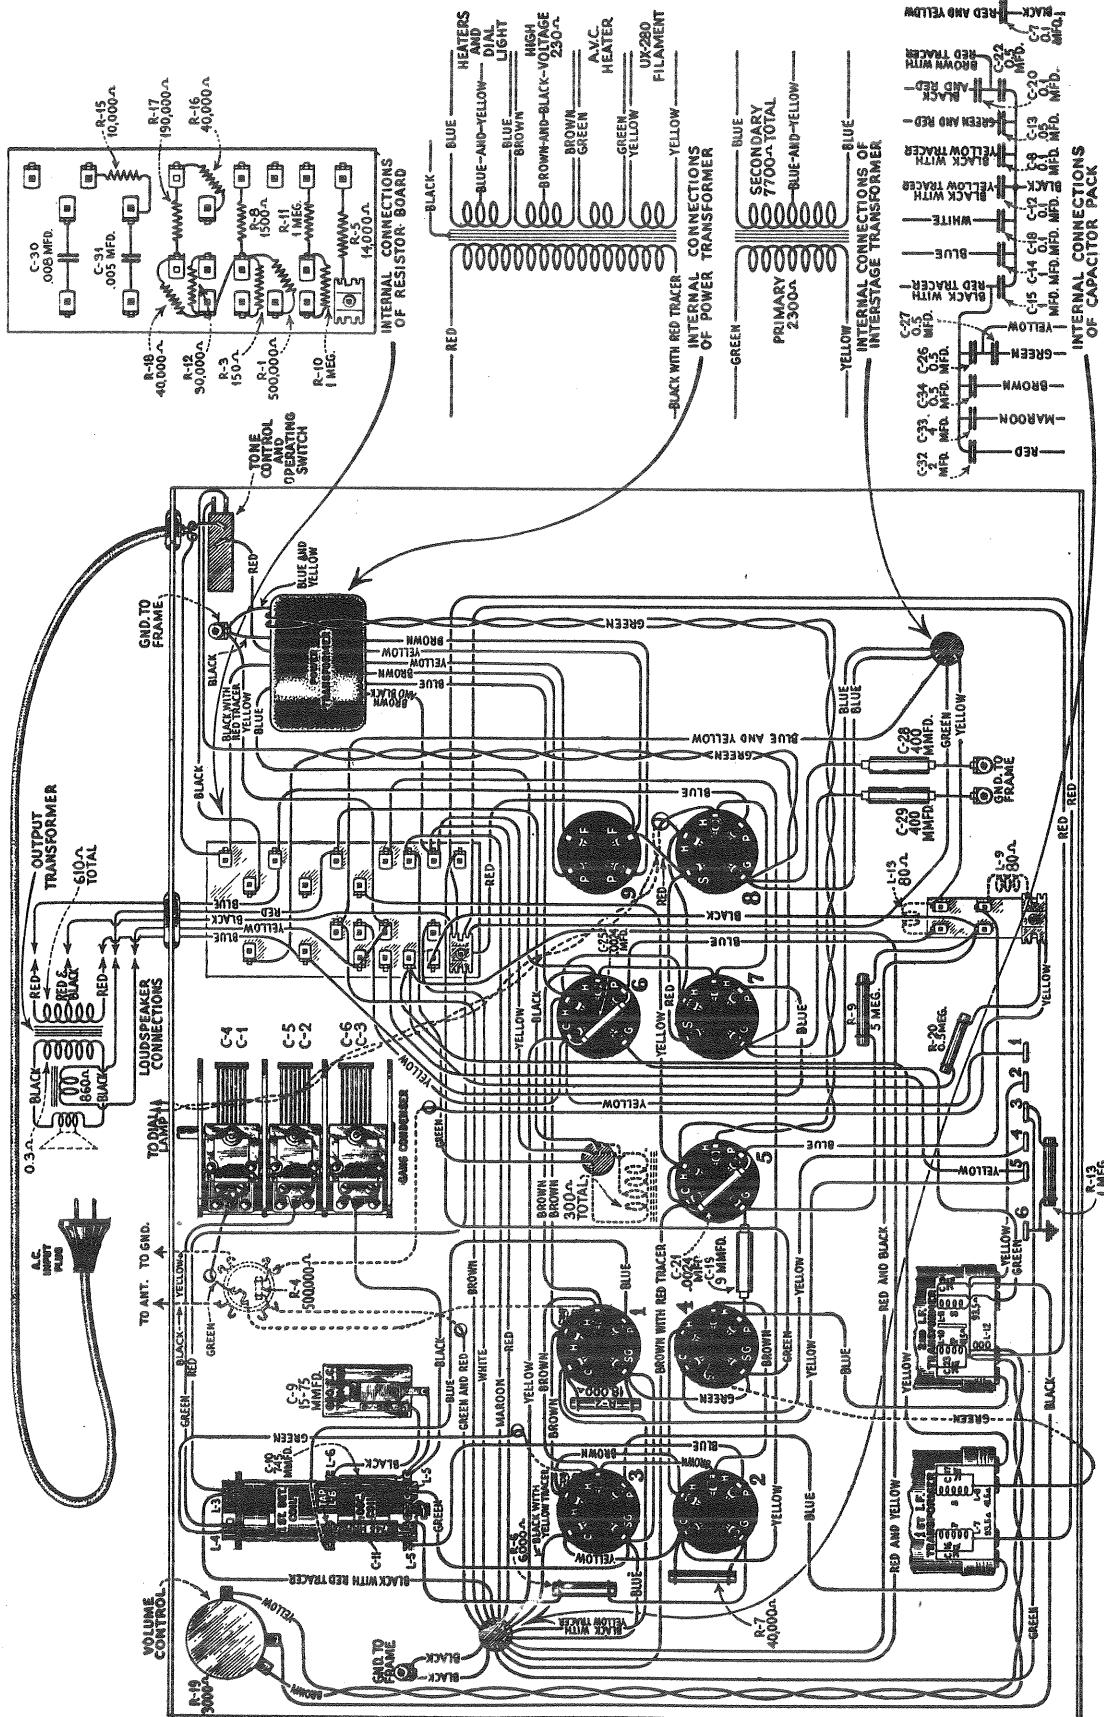
Figure 2—Wiring diagram of late production R-11
