# RCA Power Amplifier

(UNI-RECTRON—MODEL AP-935)

#### SERVICE NOTES

Third Edition-5M-June, 1928

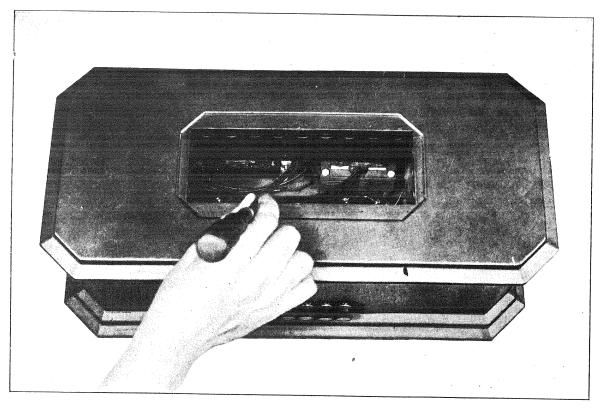
Figure 3

These tests are made by holding a steel screw driver in proximity to the iron core of the choke coil and noting the degree of magnetic pull together with the condition of the plate of the Rectron UX-216B. (See Figure 3.)

Magnetic Pull	Color of Plate	Defect
(a) Excessive	Dull red	3½ Mfd. condenser No. 2 shorted.
(b) None	White hot	3½ Mfd. condenser No. 1 shorted.
(c) None	Normal	Defective power transformer or open choke.
(d) Excessive	Normal	Shorted elements in Radio- tron UX-210.

Location of screw driver for Magnetic Pull Test

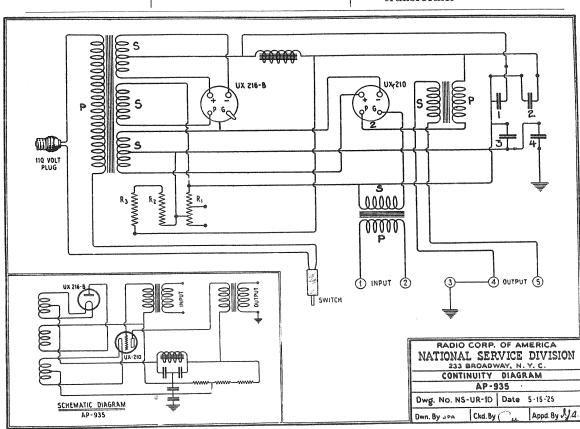
Figure 4
Continuity diagram RCA Uni-Rectron

Terminals	Correct Effect	Incorrect Effect Caused by
1 to 2	Click through primary of input transformer	Open primary input trans-
4 to 5	Click through secondary of output transformer	Open secondary output trans- former
4 to 3 4 to ground	Click through connections Click through connections	Open lead Open lead

Terminals	Correct Effect	Incorrect Effect Caused by
P1 to P2	Small scale deflection	Open high voltage winding of transformer. Open resistance unit or primary of output transformer

Terminals	Correct Effect	Incorrect Effect Caused by
—F1 to +F1	Full scale deflection	Open filament winding of power transformer
P1 to G2	Small deflection	Open (high voltage winding of transformer) (secondary of
P2 to —F2 or +F2	Half deflection	input transformer) Open (primary output transformer) (resistance unit)
P1 to —F1 or +F1	Small deflection	(filament winding) Open (choke) (filament winding) (resistance unit) (plate winding)
Ground to —F2	No deflection	Shorted condenser No. 4

The test points referred to are shown in the Continuity Diagram, Figure 4. The designations "P" and "G" refer to the plate and grid socket contacts. The number immediately following refers to the first or second socket. For example G2 indicates the grid contact of the second socket. P1 indicates the plate contact of the first socket. In the same manner the letter "F" denotes the filament contact of the tube socket indicated by the number.
