RCA Victor

Automatic Record Changing Mechanism

SERVICE NOTES

[First Edition—20M
Copyright, November, 1931]

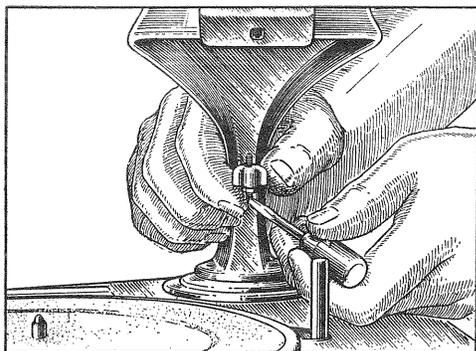
Figure 2—Adjusting height of tone arm

4. Examine the wire cable that is attached to the back of the tone arm. It should be seated on the small pulleys over which it passes.
5. Place a Home Recording needle into the pickup as far as it will go. Then lower the pickup on the side of the turntable. The needle should extend from $\frac{1}{32}$ " to $\frac{1}{16}$ " below the top of the metal edge of the turntable. If it does not, an adjustment can be made by means of a screw located under the tone arm. Lifting the arm provides accessibility to the screw. See Figure 2.

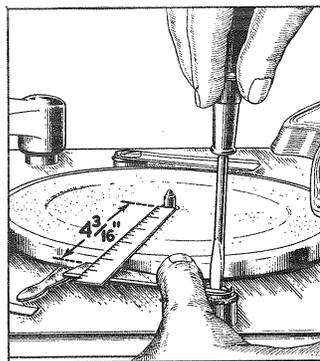
Figure 3—Adjusting elevator pad

7. After the instrument has completed one record changing operation, a ten inch record should extend about three-quarters way over each elevator pad. If this condition does not exist, an adjustment can be made by means of the screws that hold the pads in position. A pair of pliers heavily padded with cloth or other soft material should be used to hold the elevator shafts while loosening and tightening the screws. The distance from the closest part of either pad to the edge of the spindle is approximately $4\frac{3}{16}$ ". Figure 3 shows the method of making this adjustment.

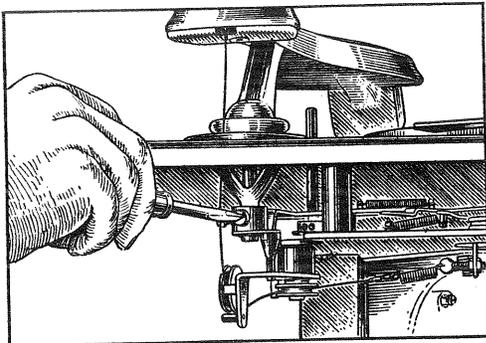
Figure 5—Adjusting position of tone arm

Failure of the needle to lower onto the smooth outer rim of the 10-inch records when the instrument is playing automatically may be caused by:

- (a) **Improper Tone Arm Setting.** Loosen the set screws as shown in Figure 5. With the mechanism out of its cycle, press the locating lever at a point near the flat spring until the lever strikes the stop screw. Holding the locating lever, Figure 17, in this position, move the front portion of the trip lever, Figure 15, until the pin against which the flat spring presses, is making contact with the locating lever. Holding the two levers in this position, move the pickup arm until the needle is $\frac{1}{16}$ " from the first groove of a standard 10-inch record. Now retighten the two set screws shown in Figure 5.

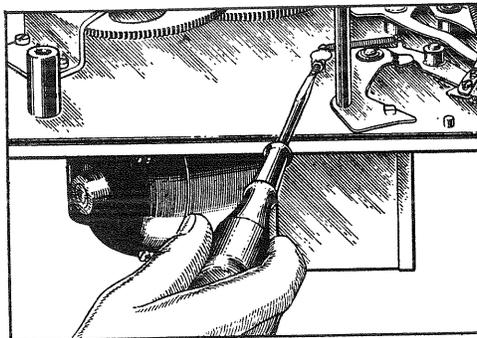
Figure 6—Adjusting tone arm locating screw

- (b) **Improper adjustment of tone arm locating screw.** This adjustment, shown in Figure 6, can be used to make a substitute adjustment for that described in (a), when the mechanism is out of the cabinet. Make the adjustment so that the needle will lower exactly $\frac{1}{16}$ " from the first groove on a standard 10-inch record. Loosen the lock nut on the adjusting screw by means of a No. 4 Spintite wrench on which the shoulder has been ground sufficiently thin for clearance. *Do not attempt to make this adjustment without first loosening the lock nut.* Tighten the lock nut when the proper adjustment has been made.

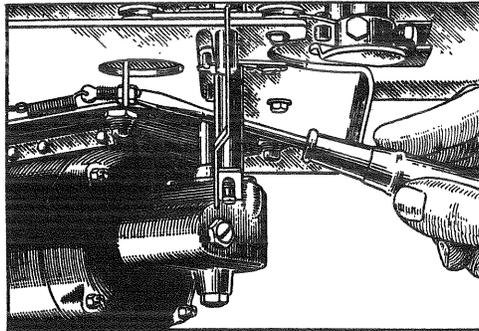
Figure 7—Adjusting tone arm cable tension screw

- (e) **Incorrect adjustment of cable tension screw.** The cable tension screw shown in Figure 7 should be so adjusted that the needle will lower smoothly onto the record without dropping. When this adjustment is obtained, the cable will be slightly loose when the needle is lowered onto a record. Loosen the lock nuts, turn the screw to the right or left as required and retighten the lock nut. Check the adjustment to make sure that the needle clears the record on the return of the tone arm. The needle should rise $\frac{1}{16}$ " from the record before any horizontal motion takes place.

Failure of the needle to clear the record surface on the return of the tone arm is caused by too loose adjustment of the cable tension. Adjust this tension as described in Section 4, Paragraph (e).

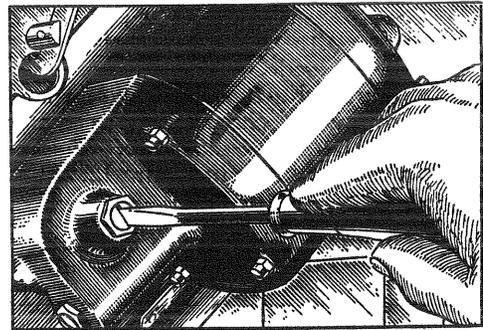
Figure 8—Adjusting spindle height

- (a) Improper turntable spindle height. The height of the turntable spindle nose should be approximately $\frac{1}{32}$ " above the inside bottom surface of the record magazine. Adjustment of this height made by means of the screw at the bottom of the motor. (See Figure 8).

- (b) Turntable spindle shaft too low. This condition will cause binding between the pawl carrier and the clutch wheel. Raise the spindle as shown in Figure 8.
- (c) Binding in any of the moving parts. Such binding may be in the slide, the magazine, the elevator shaft or the gears. The slide rollers at the left are mounted on eccentric shafts for adjustment of play. These may be so regulated as to cause excessive binding of the slide. Examine all of these parts carefully, and take any necessary steps to relieve the binding.

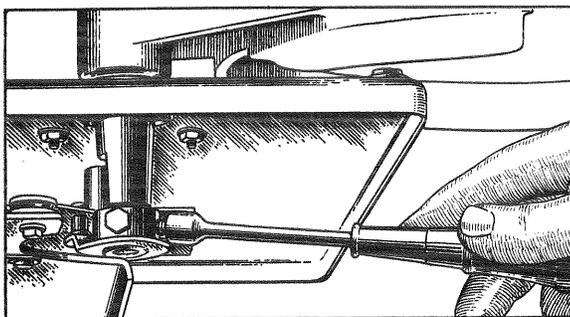
Figure 9—Magazine adjustments

- (b) Improper setting of magazine. The horizontal swing of the magazine should be so adjusted when the mechanism is out of cycle that the outer surface at its nearest point to the nearest side of the turntable spindle is $5\frac{1}{32}$ ". This can be done by loosening the two screws as shown in Figure 9, moving the magazine to its correct position and retightening the screws.

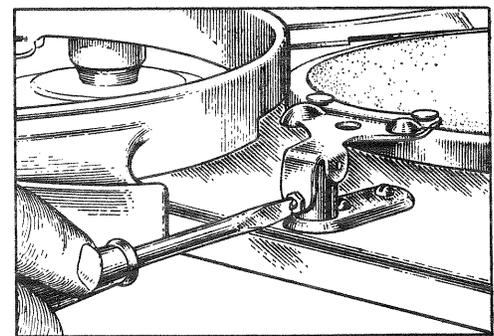
Figure 10—Record transfer lever adjustment

- (c) Improper height of record transfer lever. The small plate on top of the motor board at the left side of the turntable should be so adjusted that it will depress approximately $\frac{1}{32}$ " when the magazine swings over the turntable. When this adjustment is made correctly, the transfer lever will engage the bottom record in the magazine as the latter is swinging back into the playing position. A small adjusting screw and lock nut are provided for this adjustment. See Figure 10.

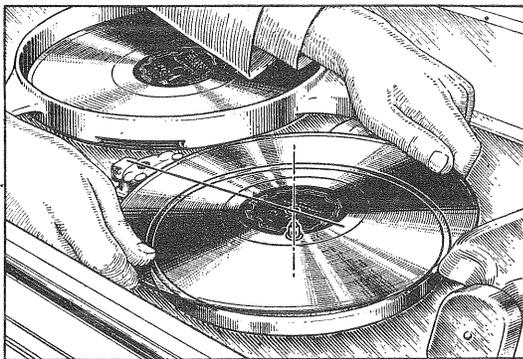
Figure 11—Method of checking transfer lever lateral adjustment

- (d) Improper Position of Record Transfer Lever. When a ten-inch record is placed so that its edge touches both pins on the record transfer lever, a line drawn from the center of the hole of the lever to the center of the record hole should pass directly over the center of the spindle. See Figure 11. The two record transfer lever mounting screws can be loosened and the lever shifted until this condition exists. Also when a record is on the turntable it should just clear this lever. Unless this adjustment is properly made the record may not center properly over the spindle.

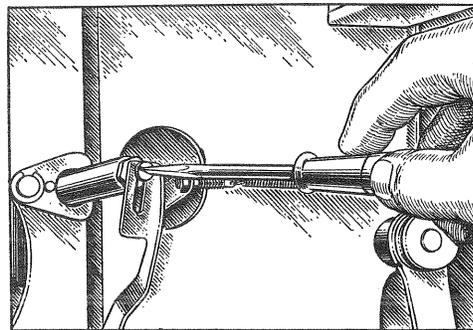
Figure 12—Adjusting height of elevator shaft

- (b) Improper adjustment of elevator shaft. The elevator shafts should rise to such a height as to give $\frac{1}{16}$ " clearance between the lowest surface of the elevator pad bottom and the top of the empty magazine. This adjustment can be made by means of the screw and lock nut as shown in Figure 12.

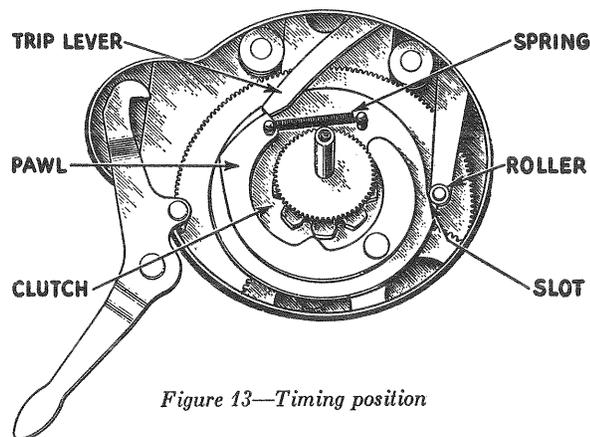
Figure 13—Timing position

Check the position of the trip lever and roller at this time to see that they are approximately as shown in Figure 13. If the various parts are not in their proper relation, the mechanism should be retimed.

- (b) Loosen the set screw in the clutch wheel and lift the wheel from the turntable spindle.
- (c) Lift the pawl carrier until it disengages from the gear.
- (d) Lower the pawl carrier into mesh with the gears so that the trip lever is touching the end of the pawl as shown in Figure 13, when the cable lever roller is engaged in the slot on the side of the pawl carrier as shown.
- (e) Recheck to see that the straight side of the cam is parallel with the slide.
- (f) Replace the clutch wheel and retighten the set screw, making sure that the set screw fits into the spot on the turntable spindle.

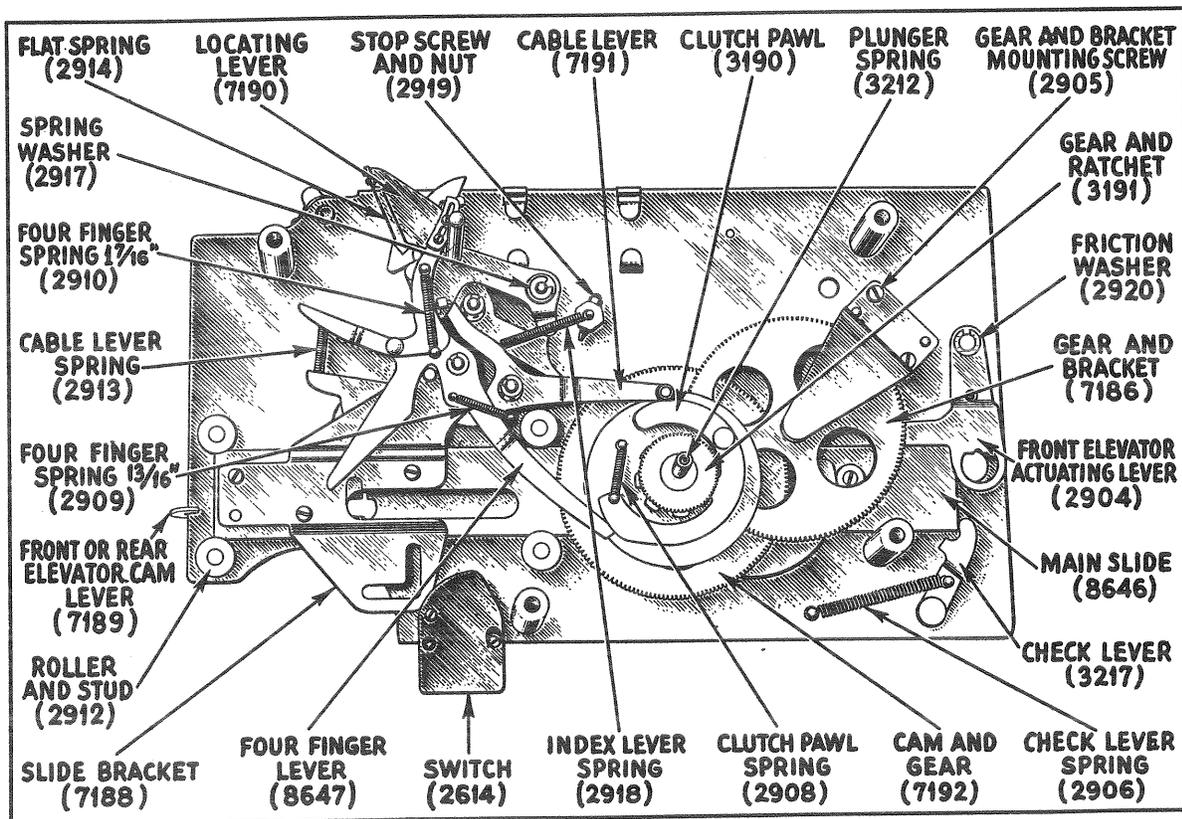
Figure 17—Top view of mechanism with plate removed

- (a) Cabinet not level. Check as indicated in Paragraph 1.
 - (b) Weak tension in spring. A flat spring presses against the tone arm lever on the under side of the motor board. See Figure 17 Page 11. Bending it so as to increase its tension against the tone arm lever will cause the needle to swing into the first record groove. Be careful not to bend it too much as excessive tension will cause the needle to skip several grooves.

- (a) Improper setting of the latch plate. Adjust the latch plate, Figure 17, by means of a small offset screw driver such as Stock No. 2930, until it makes proper contact with the latch trip when the eccentric groove is reached.
- (b) Weak spring on trip lever. A weak spring on the latch trip lever will be a cause of failure to trip.

Failure of the mechanism to stop after the "off" button has been pressed, and the mechanism has completed its cycle is caused by improper setting of the secondary stop switch. See Figure 17. The switch body should be so mounted that the contacts will open $\frac{1}{32}$ " when the cycle is completed, but will close as soon as the mechanism has tripped.

- (a) Weak spring on pawl carrier. Remove the pawl spring Figure 17, and increase its tension by removing two or three coils.
