RCA Victor

Automatic Record Changing Mechanism

SERVICE NOTES

[First Edition—20M
Copyright, November, 1931]

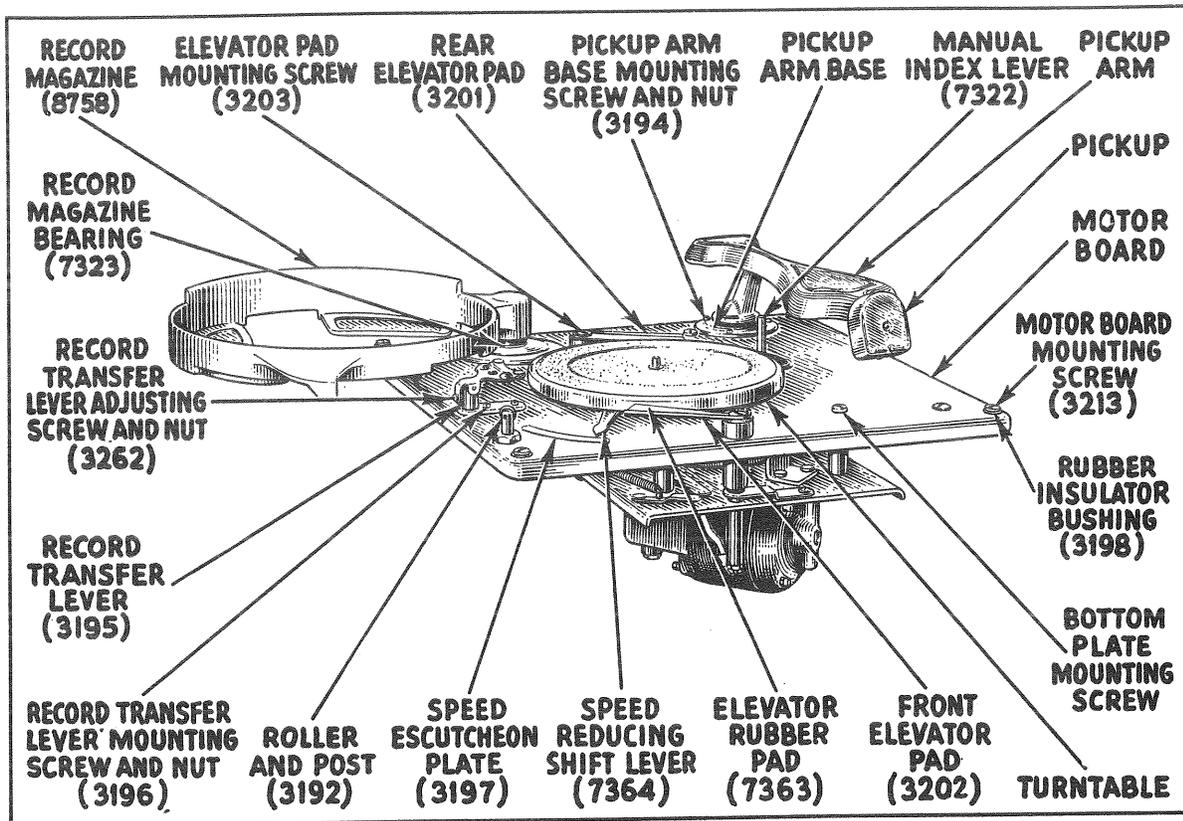
Figure 16—Top view of mechanism showing parts

- (a) Improper horizontal adjustment of elevator pads. The elevator pads Figure 16, should be so adjusted that the inside of the pad flange is $4\frac{3}{16}$ " from the nearest side of the turntable spindle. See Figure 3. Loosen the screw on top of the elevator shaft, move the pad to its correct position, holding both the pad and the elevator shaft in position and tighten the screw. Care should be observed that the ridge in the elevator shaft is not turned against the slot in the elevator shaft actuating lever so as to cut the latter. Grip the shaft with padded pliers while this adjustment is being made in order to prevent the shaft from turning. If for any reason the elevator pads have been removed, always place the one with the rubber surface toward the front of the mechanism when replacements are being made.
