Victor Model 7-1 (Alhambra I)

Wiring Diagram Alhambra I (7-1)

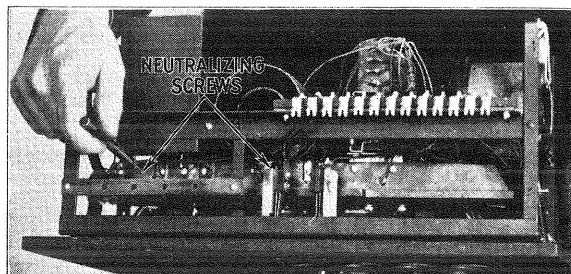
Fig. 2

- b. A screw driver, of bakelite construction (with metallic blade) similar to that shown in Fig. 2.
- c. A UX-199 Radiotron, from which one of the filament (LARGE) prongs has been sawed close to the base.
Note:—DO NOT use a tube with burnt out, broken, or shorted filament.
- d. A pair of headphones.

- a. With insulated screwdriver, shown in Fig. 2, adjust the neutralizing condenser located directly behind first tube (Fig. 3) until signal disappears—or is reduced to a minimum.
- b. Remove the special tube and re-insert the original Radiotron.
