The 45rpm Phono Gazette

Anniversary Issue

The Workbench

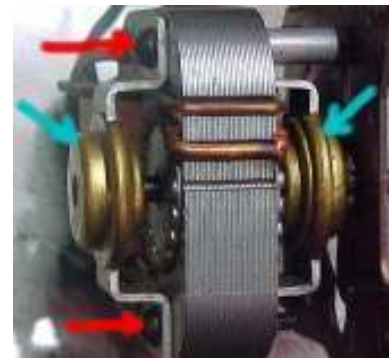
One thing you can count on after powering up a few 45 machines. One or more will run slow. First you should check the obvious. Frozen or tight idler shaft, and slick idler rubber surface can cause these symptoms. Remove the idler wheel and clean up the rubber with a rubber cleaner/revitalizer. I recommend lacquer thinner but don't leave it on the rubber too long. Wipe it off thoroughly. Clean the idler center shaft and relub with light grease or oil. If the machine still turns too slow, it's time to checkout the motor. Some motors can be brought back to speed by oiling the bearing caps. Others require taking the motor apart, cleaning the shafts and bearing caps and relubing them. When you re-assemble the motor, the alignment of the armature is critical. As you are snugging up the screws holding the armature in place, spin the armature to make sure it is free and doesn't bind.

Blue arrow- bearing cups. Red arrow- mounting screws.

While this cures many of the slow motor problems, there are some that still run too slow after all this. The problem usually occurs when the motor is cold. Many times after a couple of records play, the speed is up to spec. At this point I will swap out the motor if the speed must be right even when cold. Otherwise I suggest playing an instrumental first or let the machine run for a few minutes before playing.

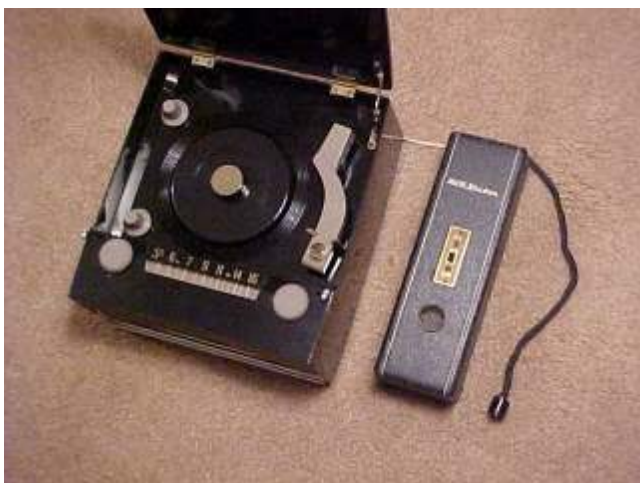
Skipper with optional power supply

The Skipper (6BY4) was manufactured in 1955 and 56. It was available in two color combinations, black and gray or pink and white. Some novel features were incorporated. A dozen records could be stored under the lid with an expandable rubber bushing which held the records in place. The radio dial was readable from the front of the unit when the lid was open. When the lid was closed another radio dial is overlaid on the original one effectively turning the dial upside down so it could be read while the unit was being carried or standing on its edge. When these units are working the sound is quite good thanks to the ceramic sonotone cartridge which was supplied. The optional power supply package was hardly ever purchased. I was lucky enough to find it at one of our Radio Club swapmeets about 5 years ago. At that time I was not aware of the scarceness of the supply until years later when I never saw another one. It connects to the skipper via a 9 pin tube socket which is mounted in the back of the player. Unfortunately I don't have a schematic of the supply but the voltages should be available on the 9 pin socket when viewing the schematic for the radio/phono itself.

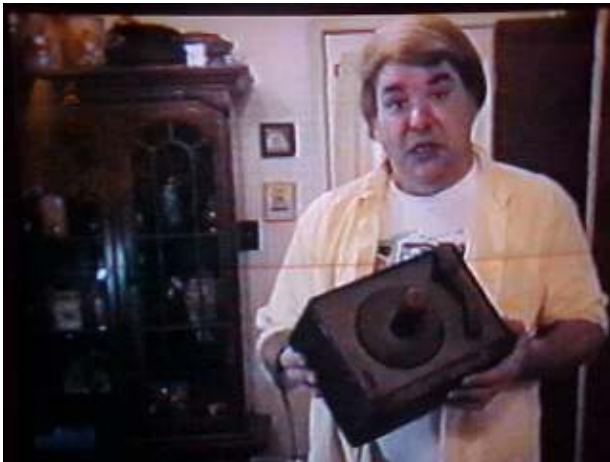
Paul Childress showing us the 45EY2 which will be totally restored

Paul Childress has put together a video which shows step by step restoration of the rp-190 record changer. He also rebuilds the amplifier and renews the cabinet on a 45EY2.

Most of the video goes in depth with the rp-190 rebuild. The chassis rebuild consists of replacing all the capacitors and the larger heat producing resistors, although we don't see the actual parts being replaced. One side of the bakelite cabinet is renewed showing Paul's cleaning and polishing procedure.

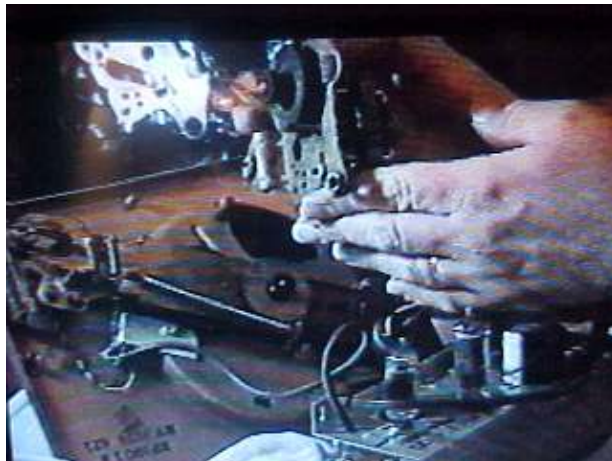
Removing motor on rp-190 changer

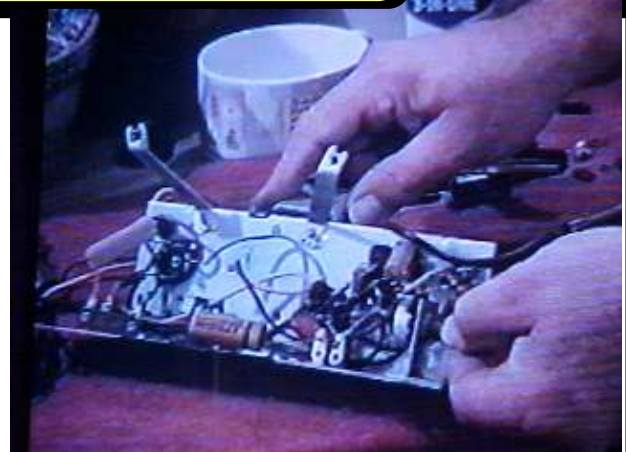
45EY2 Amplifier Recapping

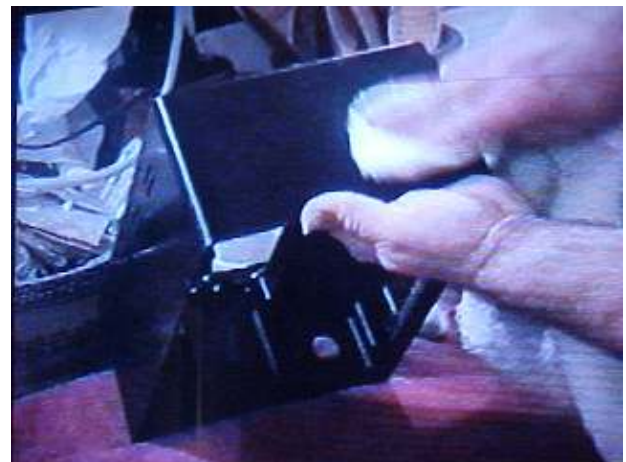
Bakelite Cabinet Renewal
