RCA Theremin

SERVICE NOTES

First Edition—5M
Copyright November 1929

RADIO-VICTOR CORPORATION OF AMERICA
233 BROADWAY, NEW YORK CITY

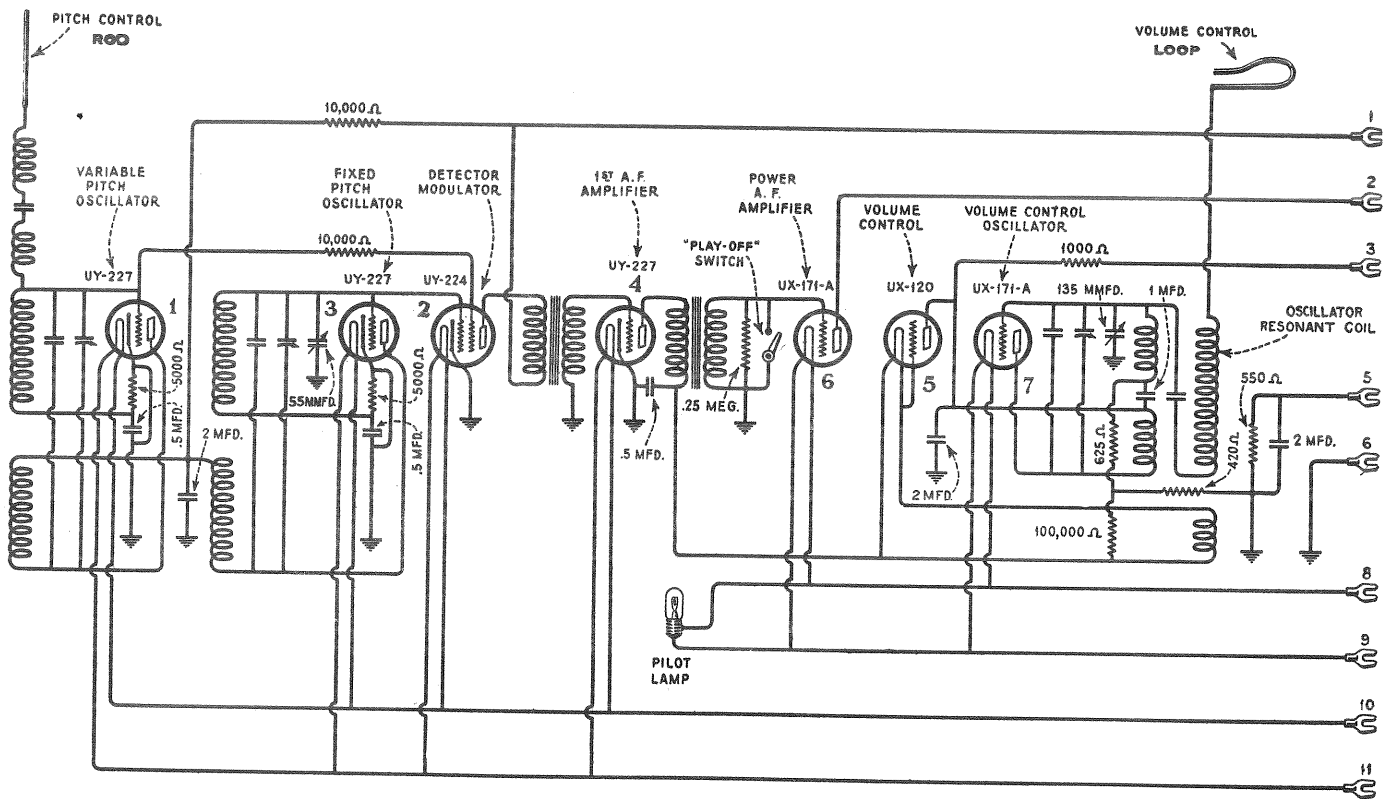
Figure 4—Schematic circuit diagram of the main assembly

Referring to the schematic circuit Figures 4 and 5 and starting from the pitch control rod we find the circuits functioning as follows:—

The pitch control rod is connected to a coil having a very high inductance. Connected to this coil is a small condenser and a small concentrated coil. This entire circuit is tuned by the distributed capacity of its coils and resonates at approximately 172 K.C. Not having any fixed capacitor connected across it for tuning, the ratio of inductance to capacitance is very high. Thus the small increase of capacity caused by the hand close to the pitch rod will cause the circuit to change its natural period considerably, a great deal more than if a large capacity and small inductance were used.

This pitch control circuit is connected to the grid side of the variable pitch control oscillator the frequency of which is slightly greater than that of the pitch control circuit. Bringing the hand close to the pitch rod will increase the parallel capacity in that circuit and thus reduce its frequency. As this capacity is reflected in the oscillator circuit a similar decrease in frequency will result in that circuit, the amount of decrease depending on the closeness of the frequency of the two circuits. Thus a greater decrease in frequency of the oscillator circuit is obtained when the pitch control circuit is close to the oscillator circuit in frequency than when it is at a greater frequency difference.

Examining the circuit diagram we find that each oscillator grid is connected to the control and screen grid respectively of a Radiotron UY-224. As the screen grid has the largest area, a 10,000-ohm resistance is connected in series with it to balance the input to this tube and have each oscillator have the same effect on the detector action. This tube is a detector or combining tube that functions much in the same

The remaining two tubes, Radiotron UX-120 and UX-171A together with the first audio frequency amplifier constitute the volume control system. Examining the UX-171A we find that it is in an oscillating circuit that oscillates at about 420 K.C. Connected to the grid side of the oscillator is the volume control loop circuit. This circuit resonates at a frequency below the oscillator frequency when the hand is entirely removed from the volume control loop. This is done for two reasons. If the two circuits were in exact resonance, the load on the oscillator would be too great and operation would be unstable. Also the pick-up current would be high and might damage the tube. The ratio of inductance to capacity in this circuit is also quite high. A small pick-up coil is wound around the inductance coil of the volume control loop circuit and when both circuits are nearly in resonance (hand entirely removed) sufficient radio frequency current flows in this pick-up coil to light the filament of the Radiotron UX-120 to which it is connected. If the plate supply circuit to the Radiotron UY-227, that is the first audio frequency amplifier, is examined we see that the current for this tube is fed through the UX-120. Thus if the UX-120 were at maximum brilliancy, maximum

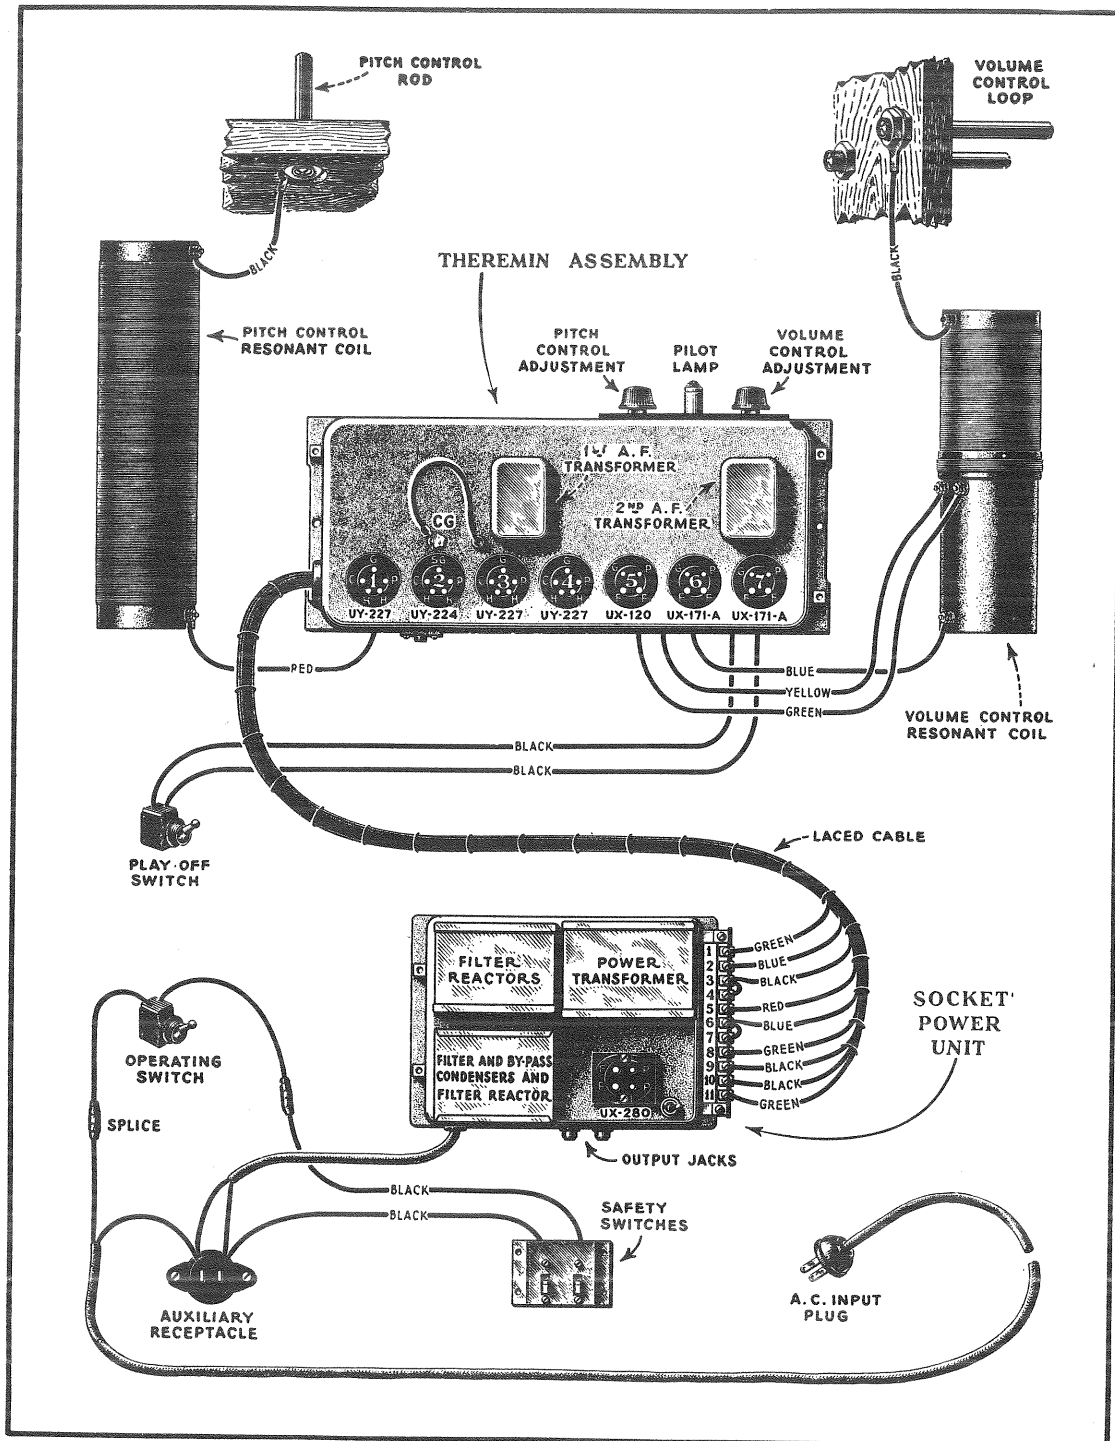
Figure 6—Complete layout and cable connections to the various assemblies

Use D.C. voltmeter with a 0-300 volt scale and at least 1,000 ohms per scale volt such as incorporated in Weston Model 537, Type 2, test set, for the D.C. voltage. The A.C. voltage may be measured with an A.C. voltmeter of suitable range. Refer to Figure 6.

The following voltages taken at each Radiotron socket with the Theremin in operating condition should prove of value when checking with test sets such as the Weston Model 537, Type 2, or others giving similar readings. The plate currents shown are not necessarily accurate for each tube, as the cable in the test set will cause some circuits to oscillate, due to its added capacity. Small variations of voltages will be caused by different tubes and line voltages. Therefore the following values must be taken as approximately those that will be found under varying conditions. Refer to Figure 6.

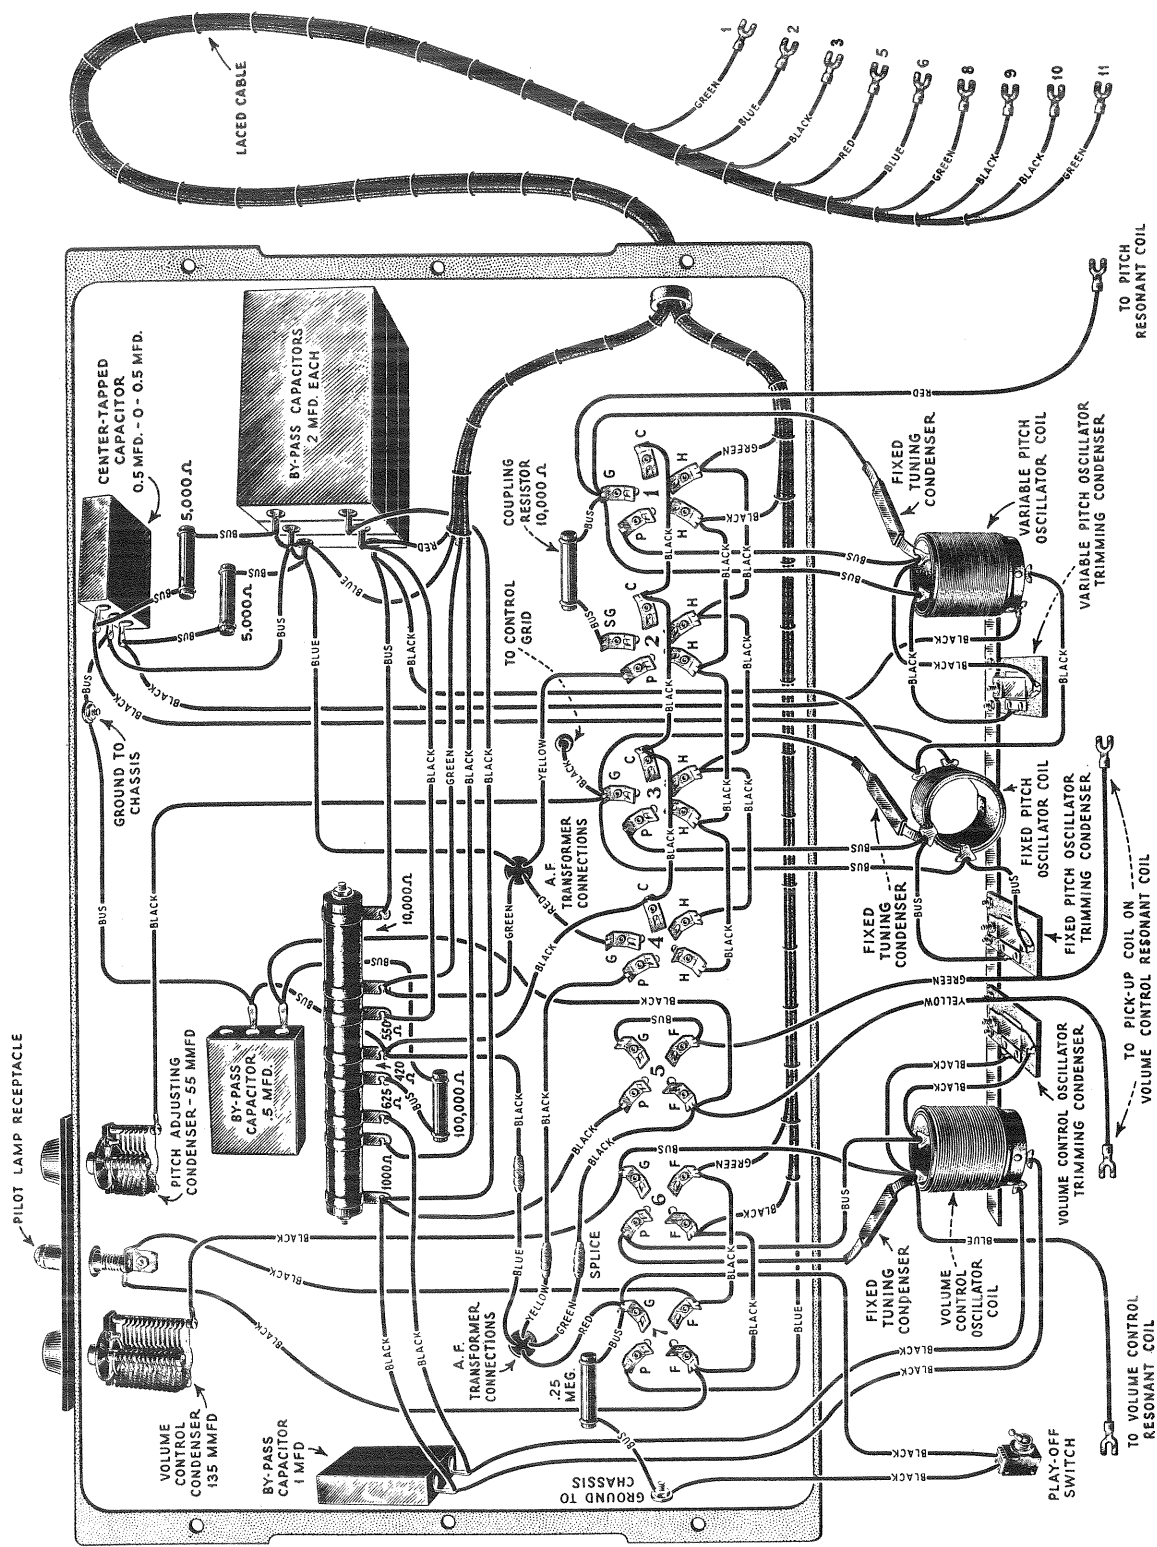
Figure 8—Wiring diagram and parts of the main assembly

Remove Radiotrons and disconnect cable—Refer to Figure 8—A D.C. voltage is used in making the tests and the resistance values given are D.C.

A pair of headphones with at least 4½ volts in series, or preferably a voltmeter with sufficient voltage to give a full scale deflection when connected across the battery terminals should be used in making these tests, for example, a 0-50 volt meter with a 45-volt "B" battery. The Radiotron socket contacts, numbers and lugs used in these tests are shown in Figure 6. The Theremin continuity wiring diagram is illustrated in Figure 8. The S. P. U. terminal numbers are shown in Figure 7.

Remove UX-280 Radiotron and Disconnect Cable —Refer to Figure 8
